**LAKE SCIOTO DAM  
PHELPS COUNTY, MISSOURI  
MO 30097**

**PHASE 1 INSPECTION REPORT**

**6 NATIONAL DAM SAFETY PROGRAM**

LAKE SCIOTO DAM  
PHELPS COUNTY, MISSOURI  
MISSOURI INVENTORY NO. 30097

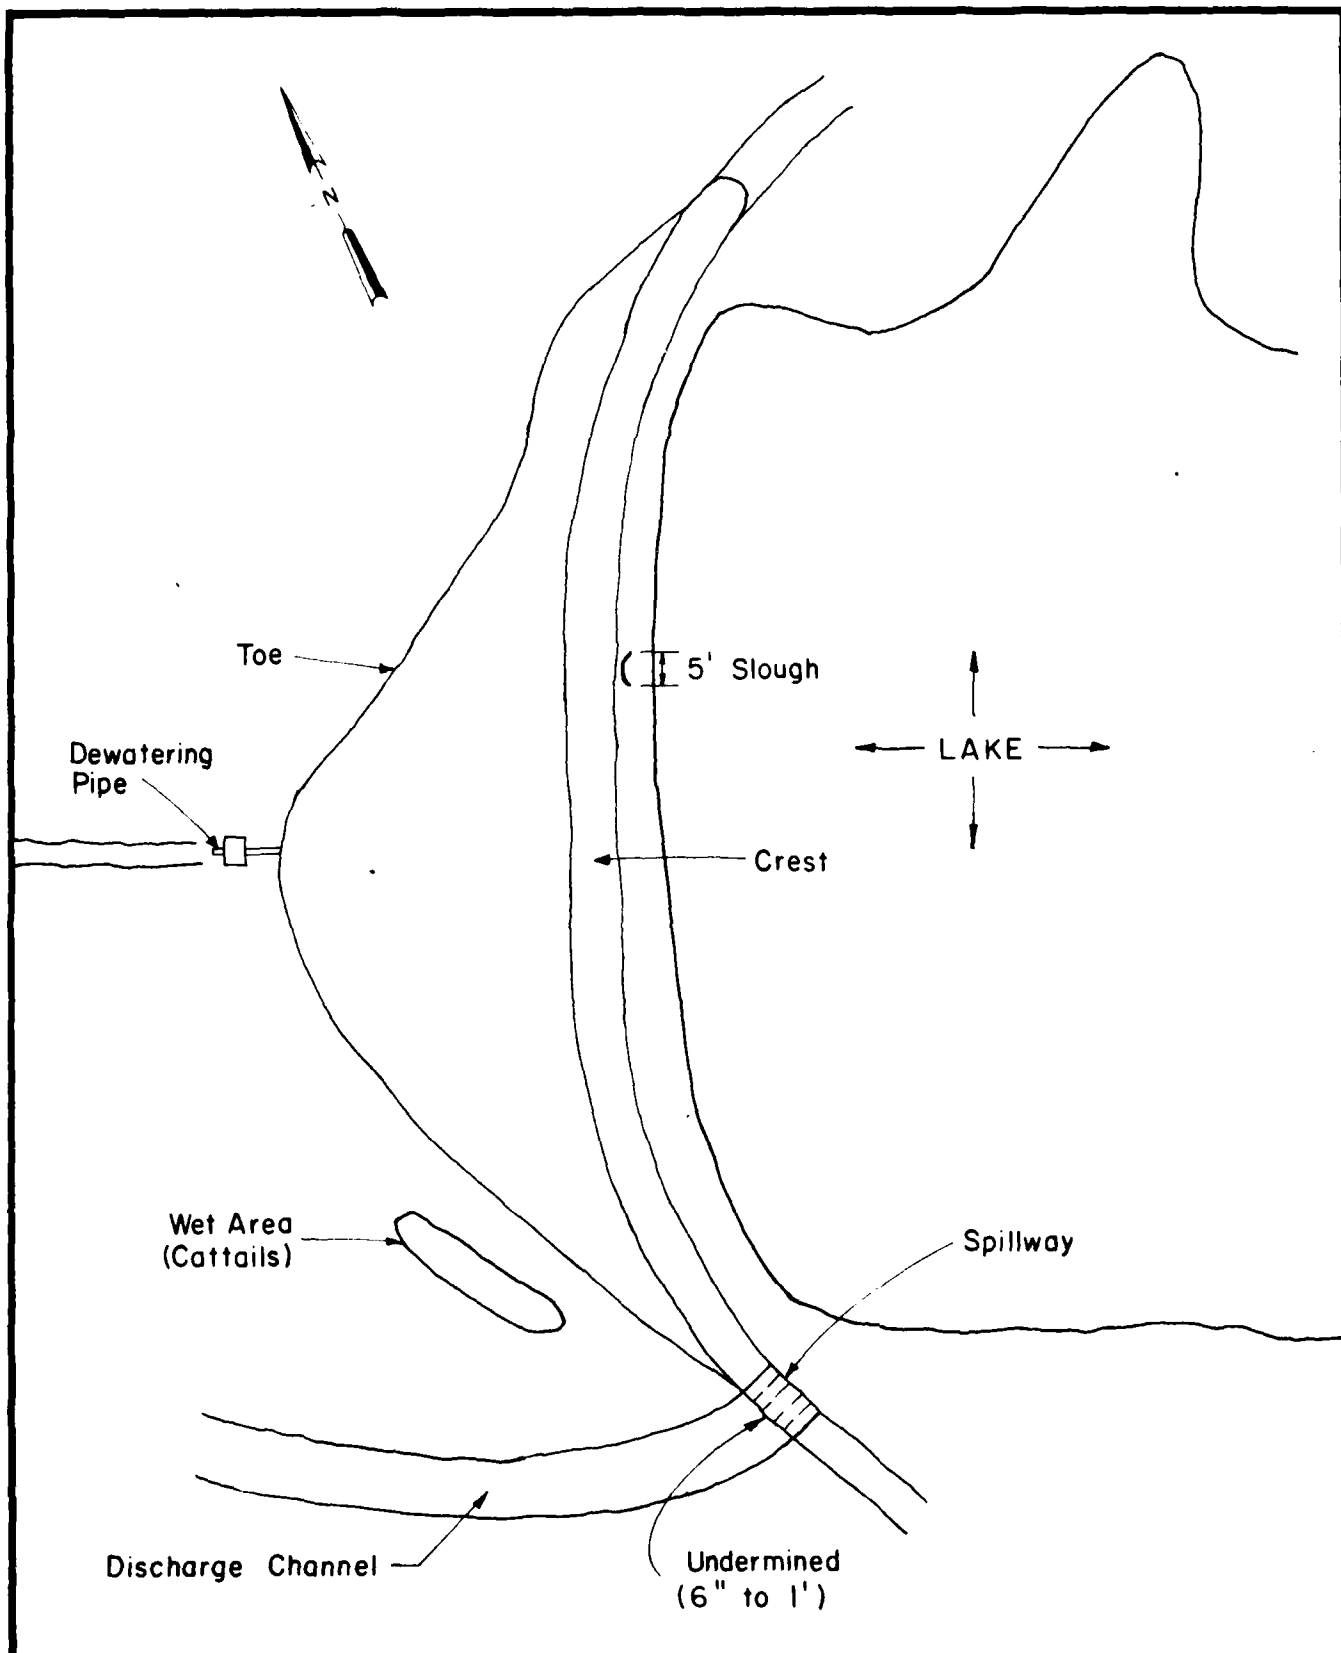
# PLAN SKETCH OF FEATURES

The dam embankment appears to be in good condition. There is no wave protection for the upstream embankment face, and some sloughing and minor erosion was noted. The embankment crest is clear and fairly level. A gravel road passes along the crest. The dam was constructed slightly concave downstream (see Photos 2 and 3). The downstream embankment face is clear except for some widely scattered small tree and brush growth. A seepage area was observed at the left abutment-dam contact (see Sheet 4, Appendix A). Although no seepage flows were noted, the area was wet and soft, with cattail growth (see Photo 8). Sheet 5 of Appendix A presents a plan sketch of the dam showing observed features.
